LIGHTNING STRIKES

A VILLAGE OF 356ERS
CAME TOGETHER TO OVERCOME
ONE OWNER'S IMPROBABLE
RUN OF BAD LUCK

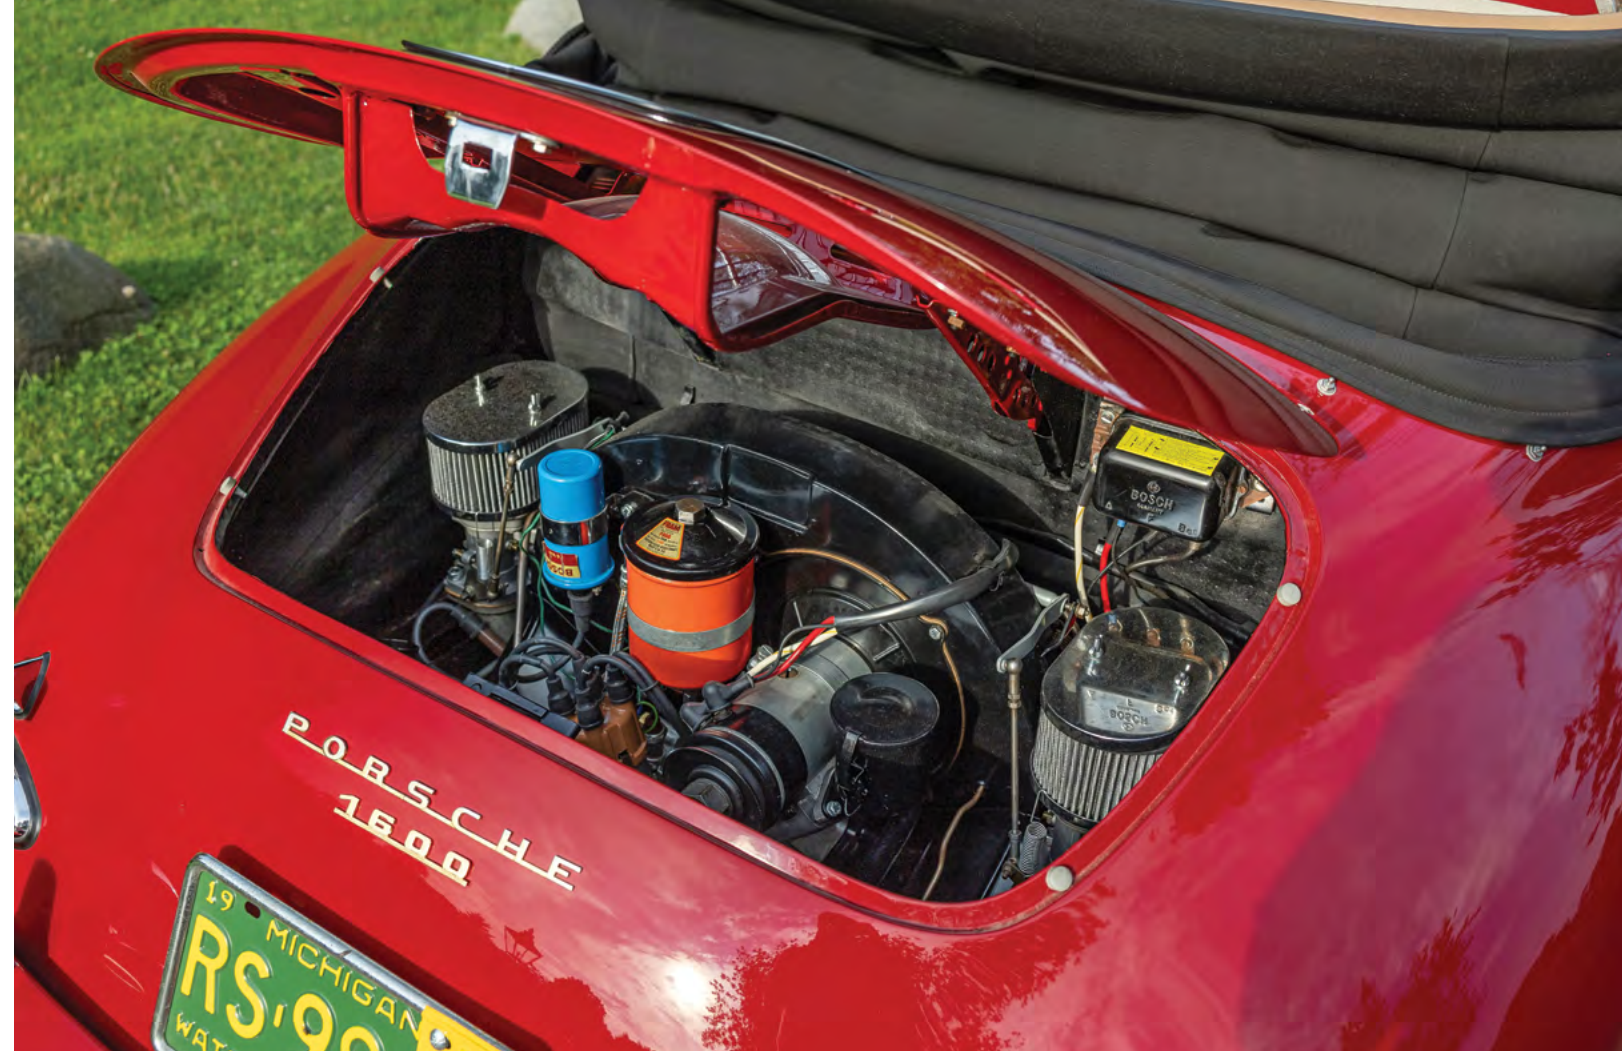
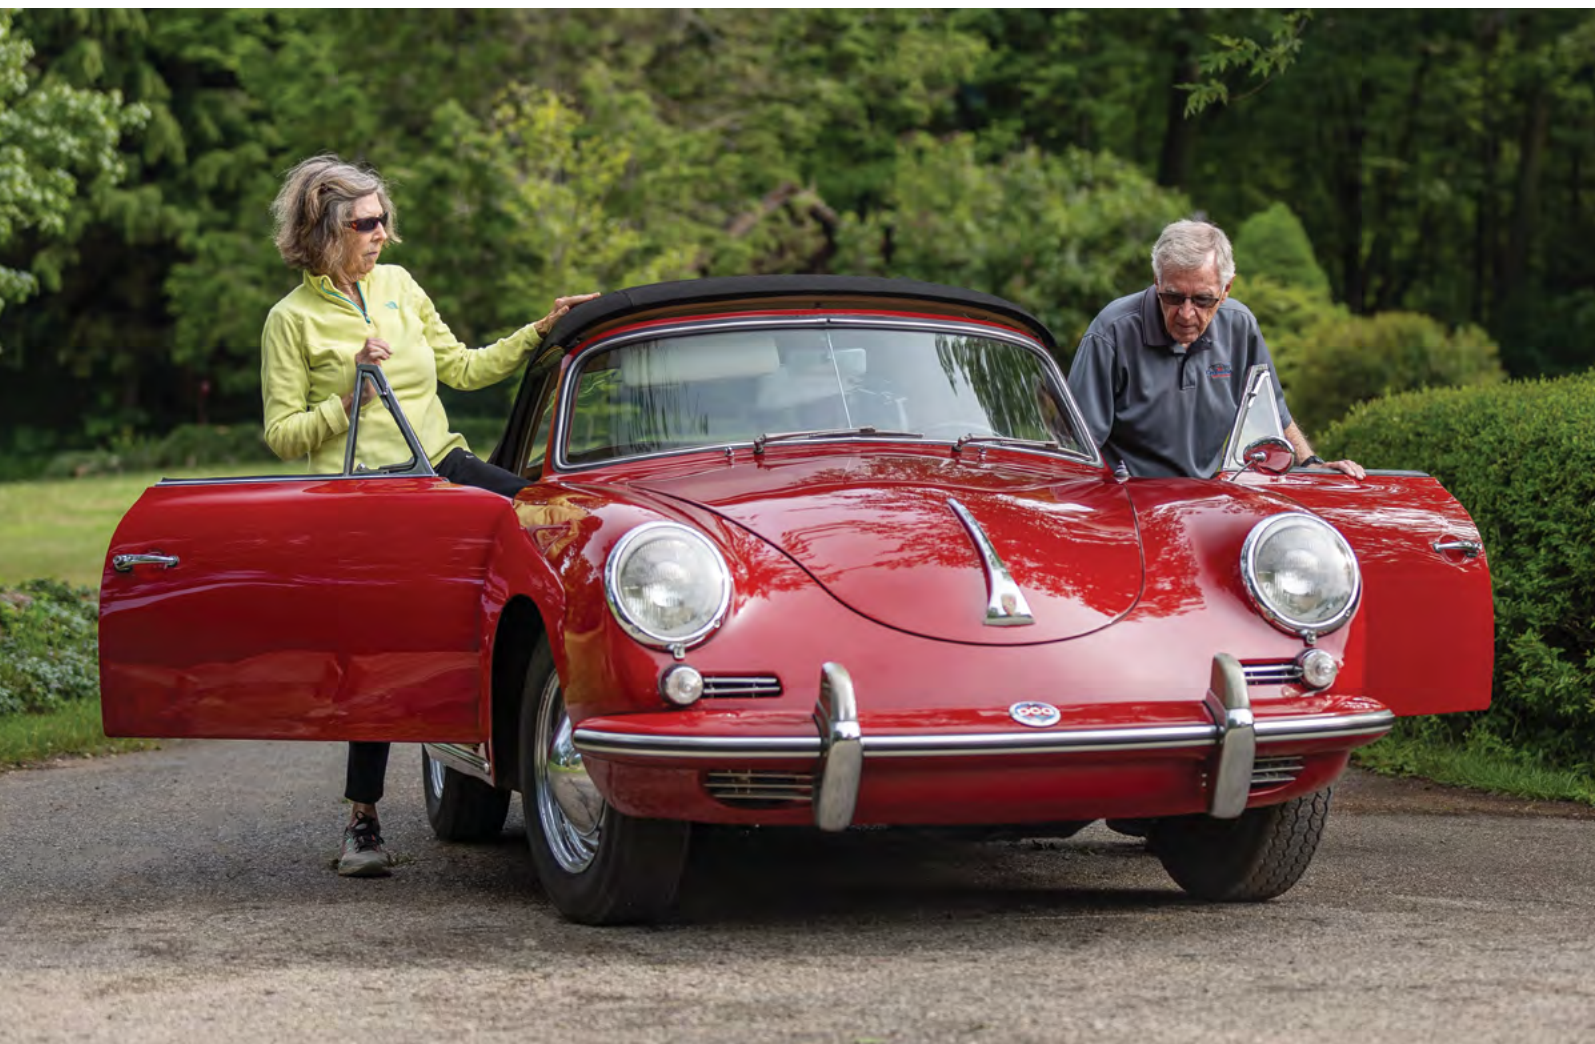
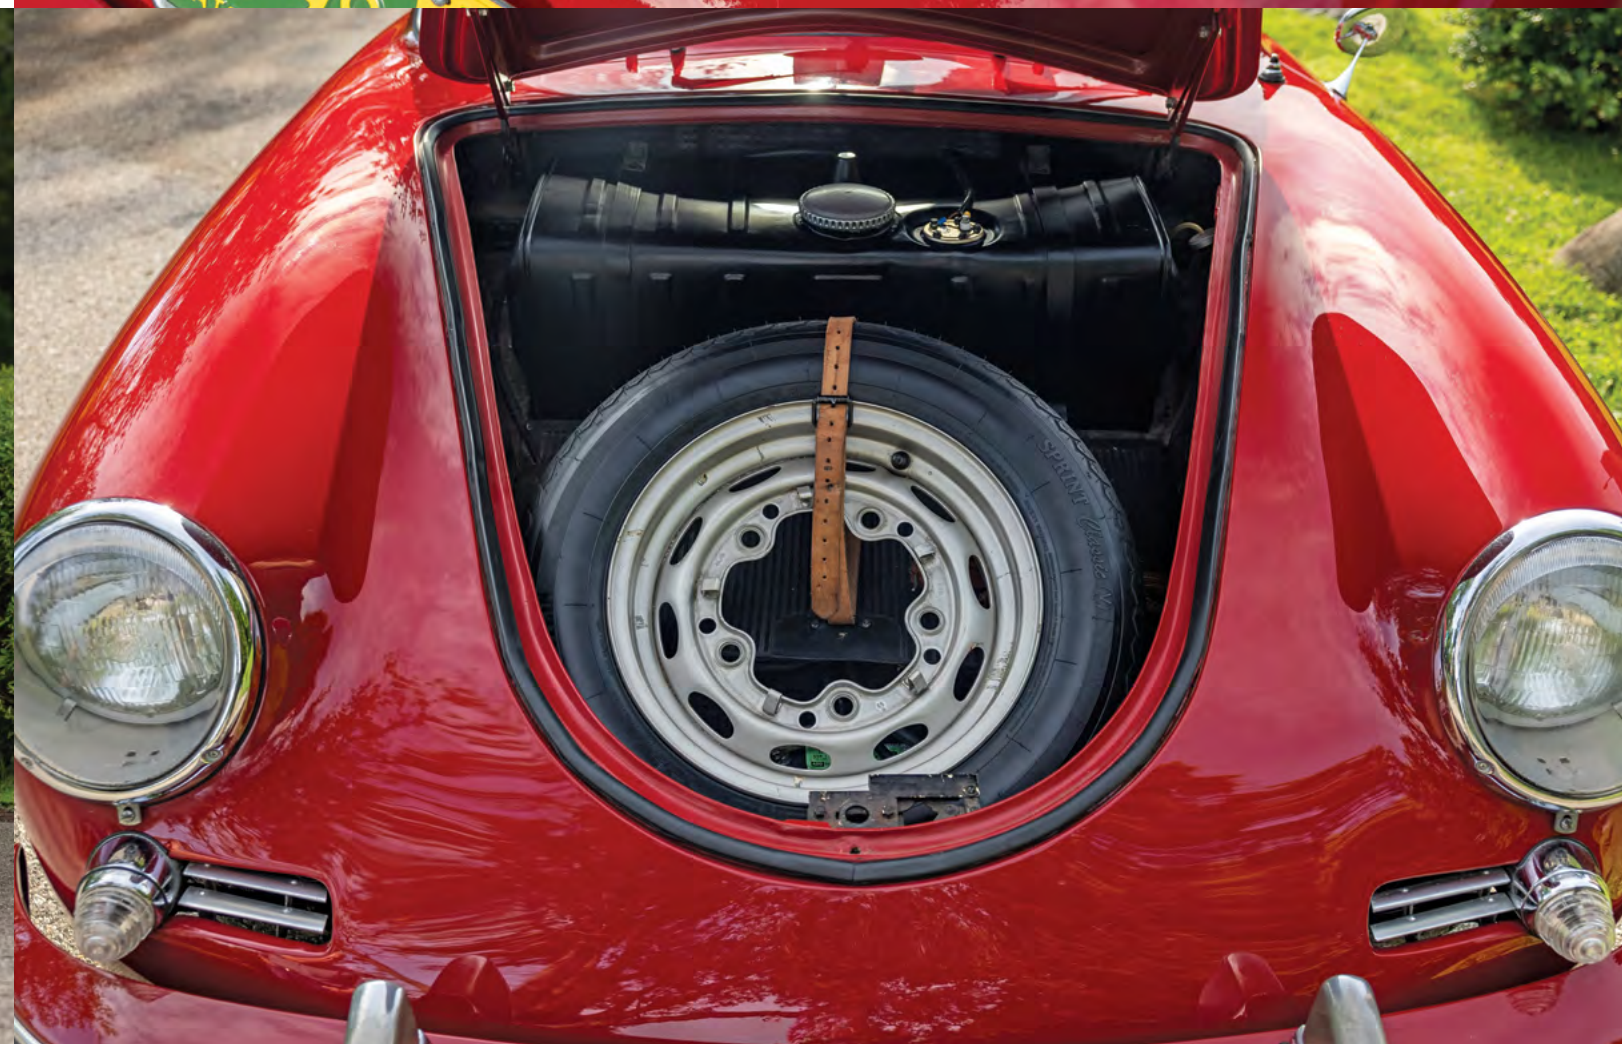
Pat Yanahan (pictured below with Sugie) gathered a crew of professionals and volunteers to resurrect this 356B, from a charred and dented beginning to perfection. **Opposite Page:** Paul Masanek rebuilt the engine and renewed the electrical system after the catastrophic fire.

Paul Masanek, an expert engine builder and electrical engineer, picks up the story. “When Pat asked me to help with the engine, it first appeared only to have cosmetic and wiring damage. When we removed the engine, it became apparent water had remained inside. The water pooled in the engine, eventually resulting in rust damage to the engine’s internals. I discovered that the mechanical fuel pump must have failed at some point [in the car’s past], and some mechanic installed an electric fuel pump. I imagine that when the fire started, the electric fuel pump continued to fuel the fire even [after] the engine stopped.”

Pat continued to apprise Sugie and Luke with details about the damage and progress being made. Damage was extensive and progress was slow. “We received the okay to rebuild the engine and perform all the engine compartment repairs,” Paul said. “I procured a set of pistons and cylinders from a nationally known supplier. Unfortunately, the cylinders were defective. The cast iron crumbled and flaked into the oil, creating an abrasive slurry.” This killed the engine yet again. “Replacement pistons and cylinders, a new crank, rods, and re-machined cam journals were now needed.” From bad to worse, right?

Fortunately, Martin expertly repaired the case, preserving the numbers-matching engine. Also, the mechanical fuel pump was repaired and a switch was installed to operate the electric fuel pump, but only to prime the carburetors. Not only did Paul build more horsepower into the car, he also improved its stopping power. He replaced the original single-circuit brake system with a safer,

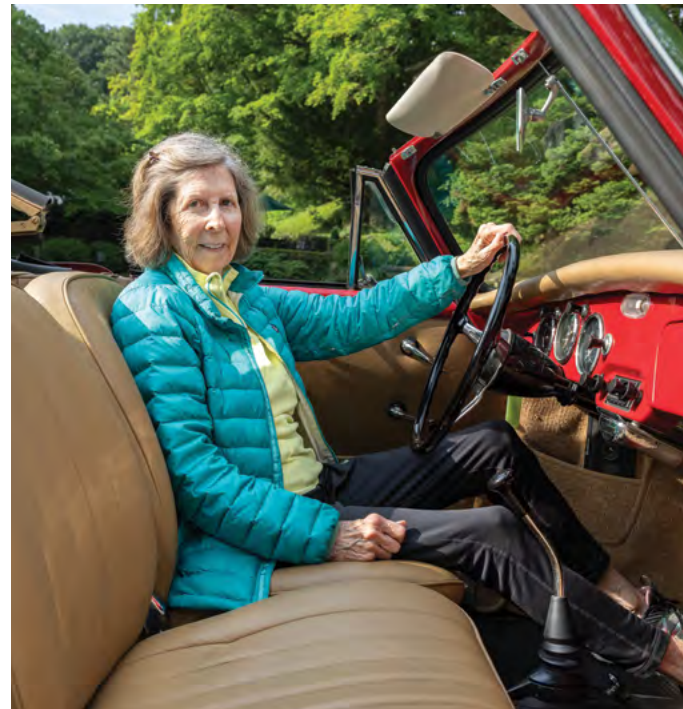
The beautiful leather interior of Sugie’s cab was cleaned, oiled, and re-dyed to complement its Ruby Red exterior.

Underbody Seal Schutz. After prepping the body for paint, Mike used PPG single-stage paint to exactly match its factory finish—Ruby Red. Although undamaged by the fire, the interior was tired. Pat cleaned the smoky haze from the plastic rear window. He removed the original leather seats and cleaned, oiled, and re-dyed the leather to restore its buttery soft, caramel-colored texture. Prestige Auto Interiors rebuilt the seats, tightening the springs and replenishing padding. With all the starts, stops, and supply-chain delays, the restoration took nearly two years to complete. The car returned to Sugie by flatbed, this time securely immobilized.

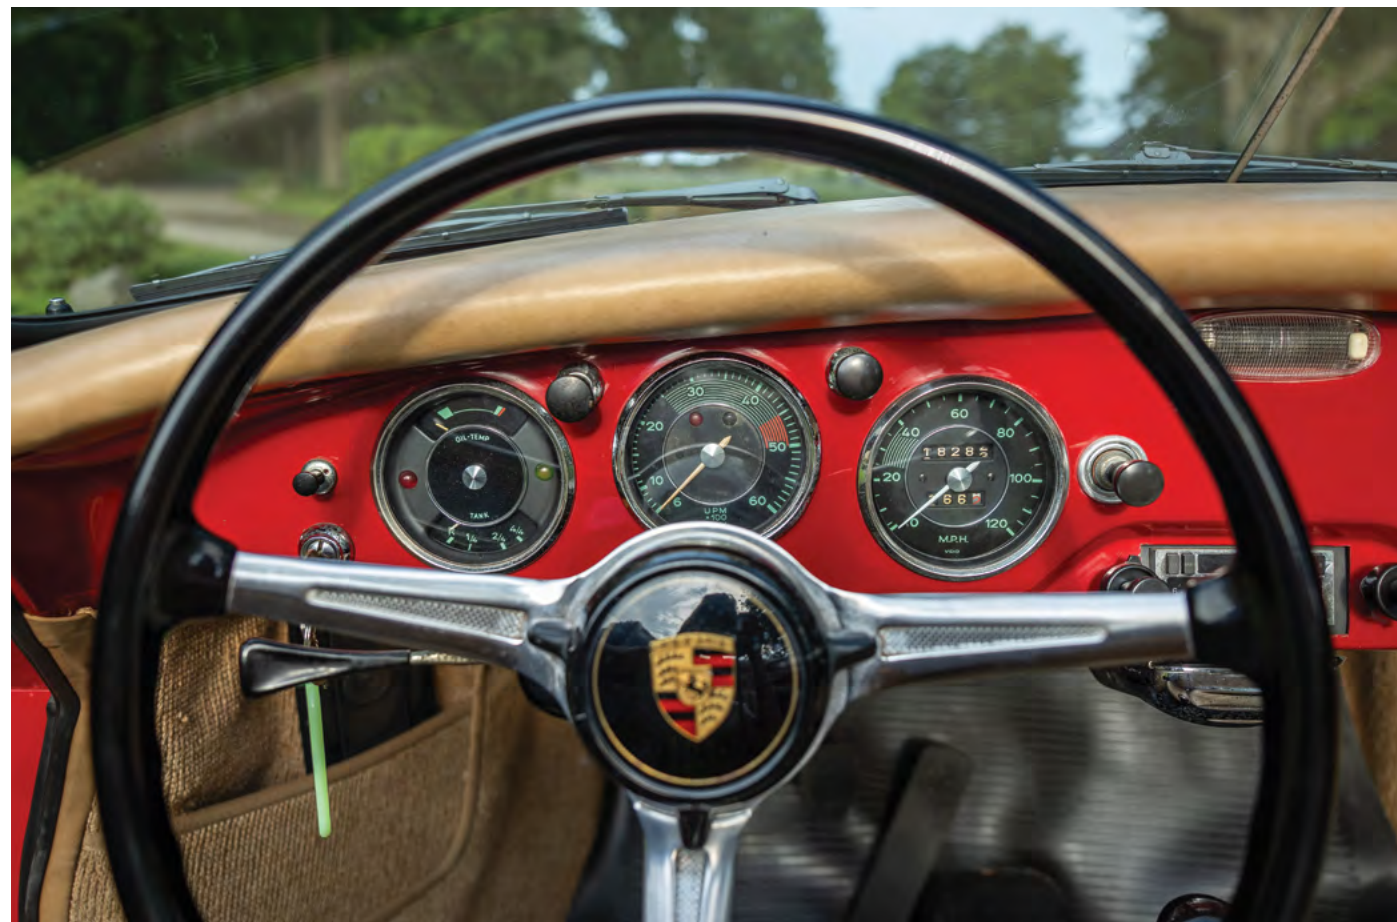
Above: No Bondo here! Mike Louis and Fred Mayer banged the dents smooth, then resprayed the entire car better than factory-new. **Below:** Sugie Young stands proudly with her cabriolet once again, after its two-year restoration. She will check the tie-down straps personally next time her car is flat-bedded.

While Paul rehabilitated the mechanics of the car, a pair of experts tended to the body. Mike Luurs and Fred Mayer of Luurs Hot Rod Shop in Romeoville, Illinois, worked for weeks to restore the car to better than new. Fred did all the body work, banging out the dents and wrinkles by hand—no Bondo shortcuts. Mike removed all the surface rust from the pan and the wheel wells, then applied Wurth
